Tubercles and Localized Corrosion on Carbon Steel

B.J. Little, R.I. Ray and J.S. Lee Naval Research Laboratory, Stennis Space Center, MS 39529-5004, USA, blittle@nrlssc.navy.mil, Fax: 228-688-4149

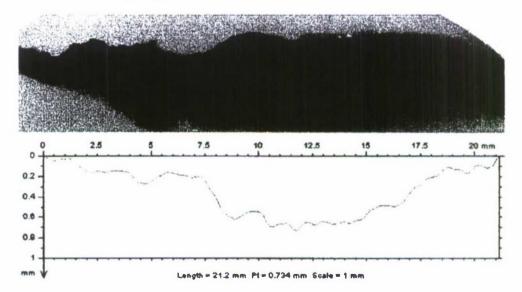
All DSH tubercles were associated with localized corrosion, i.e., pitting (Figure 3). Pit volume, i.e., mass loss (depth x area) increased with time over a 3-year period. By year-3, the distribution of pit depths had increased (70-630 μ m) with a metal loss of 215.25 mm³ over 625 mm². Increase in pit depth with time was not linear.

Figure 3. Cross section of tubercle and profile of pitting associated with DSH tubercle.

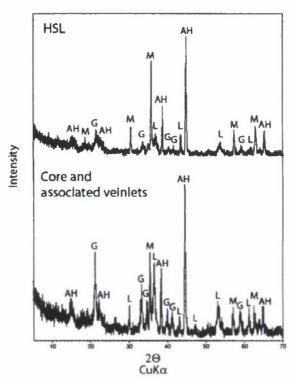
One representative tubercle was examined in detail. Based on its internal morphology it is similar to Group 1a discussed above. It had yellowish-brown colored core material composed of goethite and moderate amounts of lepidocrocite and veinlets composed of hard black non-metallic magnetite (Figure 6). This region was overlain by a black hard shell layer that has a metallic luster and was composed of magnetite with minor amounts of goethite and lepidocrocite. A very thin (less than 0.5 mm) surface layer overlies all and was reddish in colored material. Because this layer was so thin the mineralogy and chemistry could not be examined. Biomineralized bacterial sheaths were located within the core region.

Figure 6. Powder X-ray diffraction patterns for the core and associated veinlets and hard shell layer (HSL) for a representative iron tubercle from HPIW. G = goethite (alpha-FeOOH), L = lepidocrocite (gamma-FeOOH), M = magnetite (Fe3O4), and AH = aluminum holder that the samples were analyzed.
